# EVANSVILLE

## Health Clinic

### Alaska Rural Primary Care Facility

#### Code and Condition Survey Report

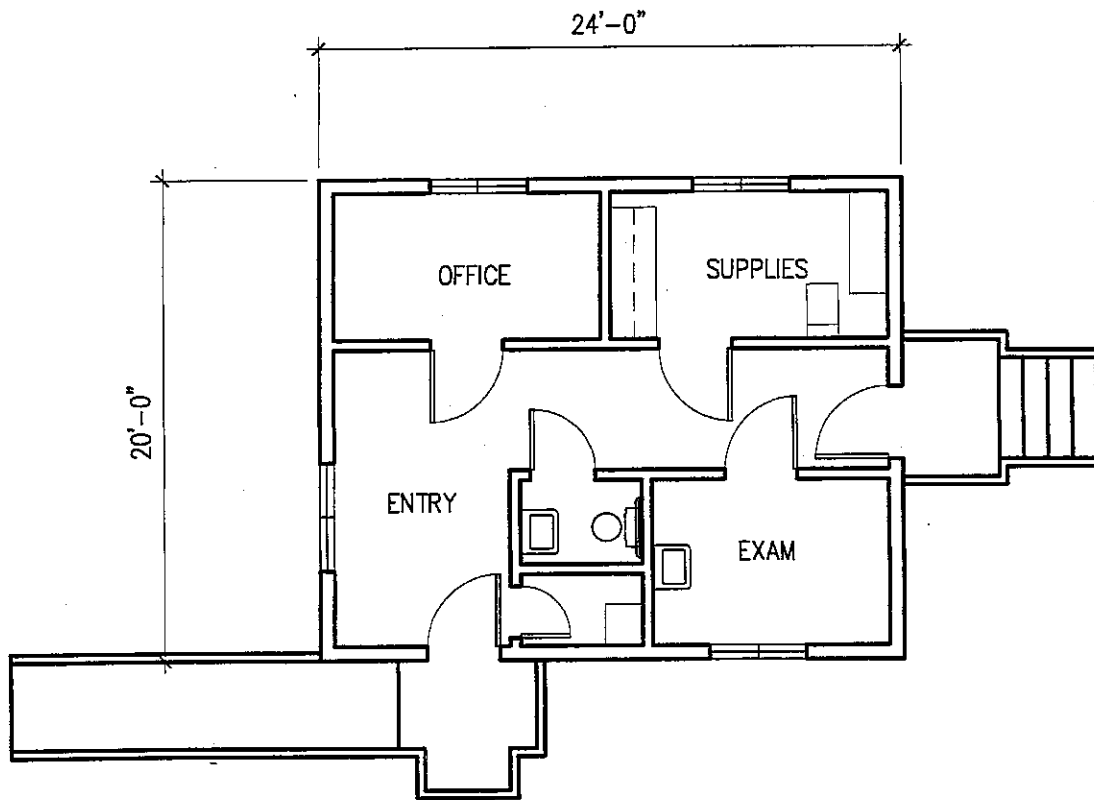
**FLOOR PLAN**

An analysis of the existing building's program functions follows. Please also refer to the floor plan in Section H:

- **Arctic Entries:** None provided.
- **Waiting:** The waiting area has been carved out of the corridor. No separate waiting area is provided.
- **Trauma/Telemed/Exam:** None provided.
- **Office/Exam:** The exam room is small but functional.
- **Administration/Records:** The administration/records area is small but functional.

- **Pharmacy/Lab:** None provided.
- **Specialty Clinics:** Specialty clinics require the use of one of the exam rooms and the corridor space. This is a disruption to ongoing clinic activities.
- **Patient Holding/Sleep:** None provided in the clinic.
- **Storage:** A small storage room keeps the main medical/medicinal supplies. It is well organized but smaller than necessary.
- **HC Toilet Room:** The toilet room lacks adequate accessible clearance and lacks accessible fixtures.
- **Janitor Closet:** None provided.
- **Ancillary Spaces:** There are no ancillary spaces in this clinic.
